SECOND CONNECTICUT LAKE DAM

NH 00187

PHASE I INSPECTION REPORT  
NATIONAL DAM INSPECTION PROGRAM

Identification No.: NH 00187  
Name of Dam: Second Connecticut Lake Dam  
Town: Pittsburg  
County & State: Coos, New Hampshire  
Stream: Connecticut River  
Date of Inspection: June 28, and 29, 1978

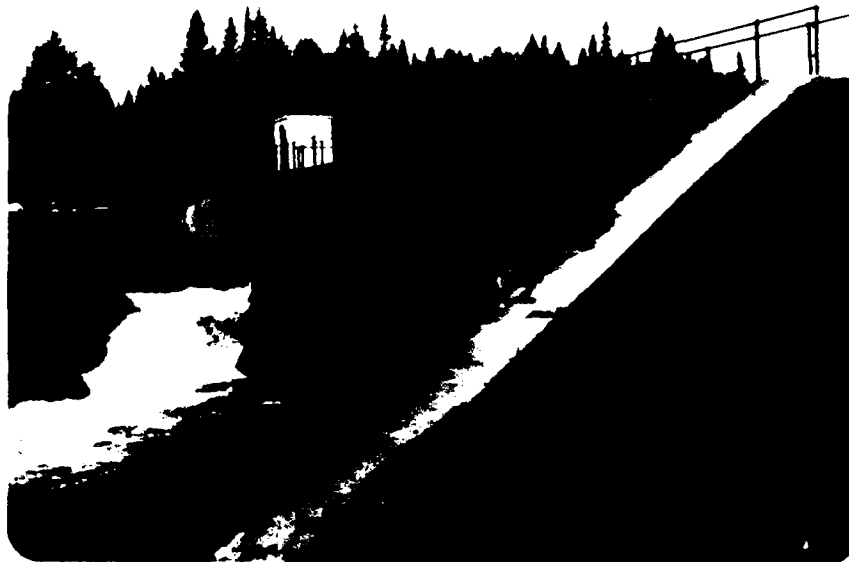
1. South abutment and downstream side of dam, looking north.

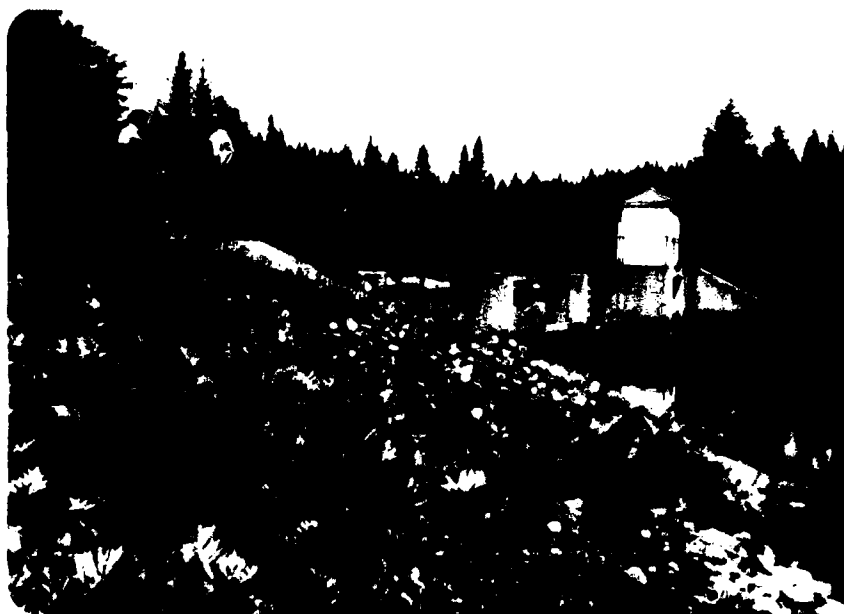
2. Upstream side of dam, looking north.

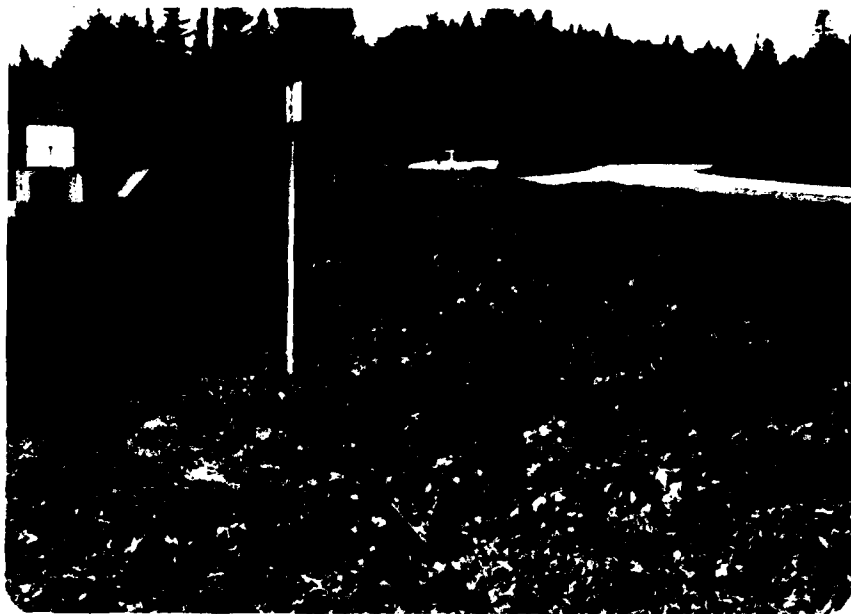
3. Upstream slope of north dike by Route 3 highway.

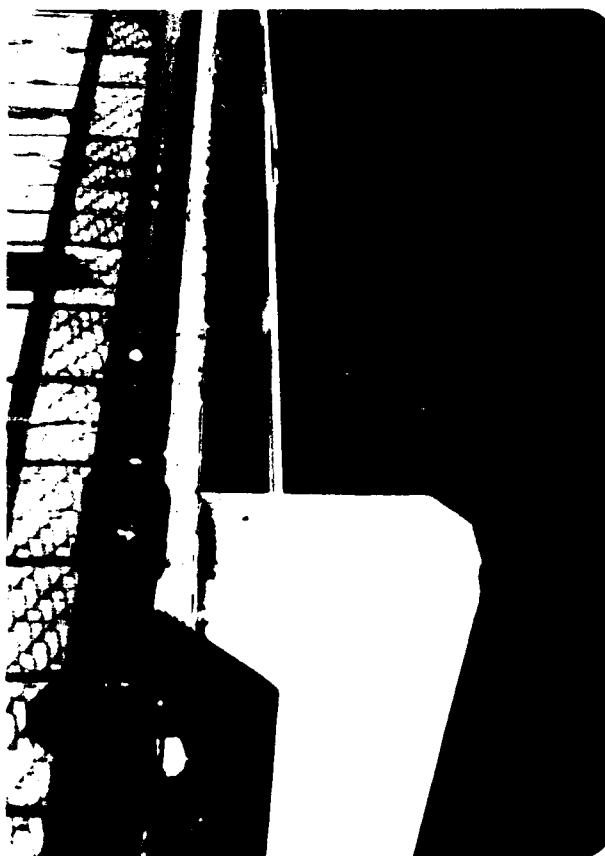
7. Spillway flashboards, pins  
and upstream concrete pier,  
looking north.

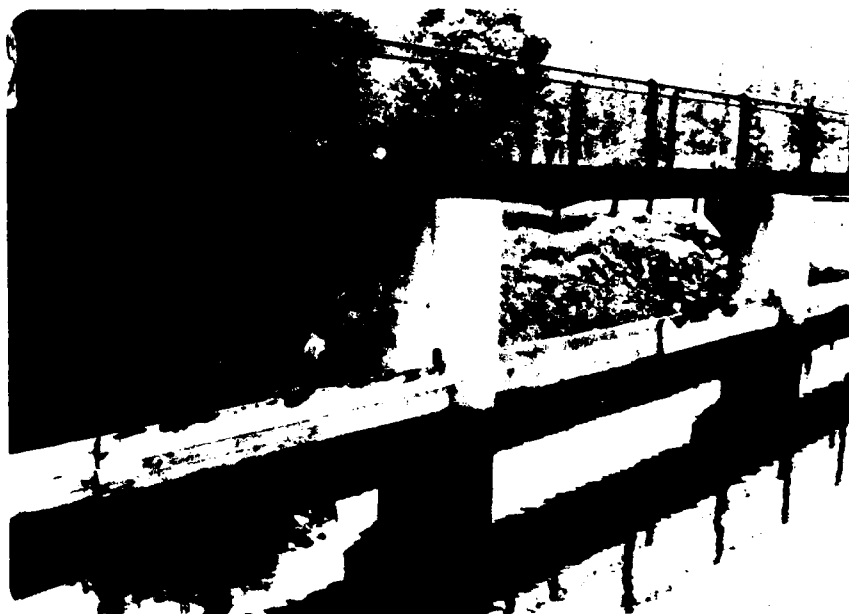
8. Spillway flashboards and footbridge, looking northwest.

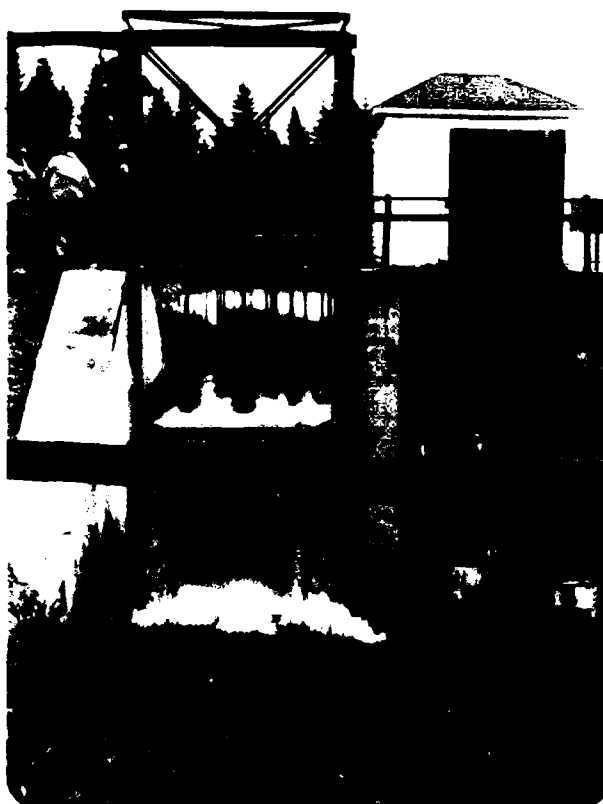
9. North abutment, stop log sluice and gate structure.

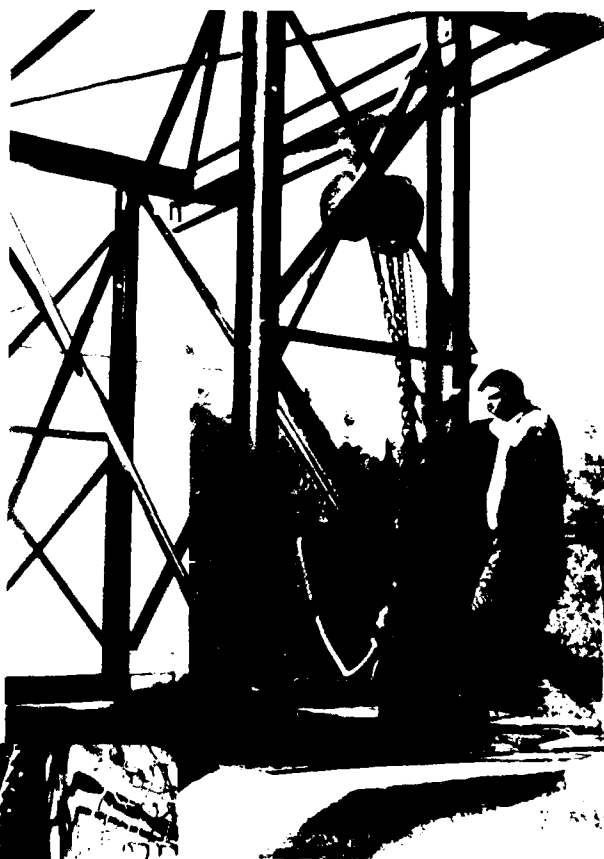
11. Chain hoist for  
stop logs, looking  
north.
